**Project No. 2**  
**COIL INSPECTION TROLLEY**

**CLIENT: MASCI**      **LOCATION: Cambridge, Ontario**

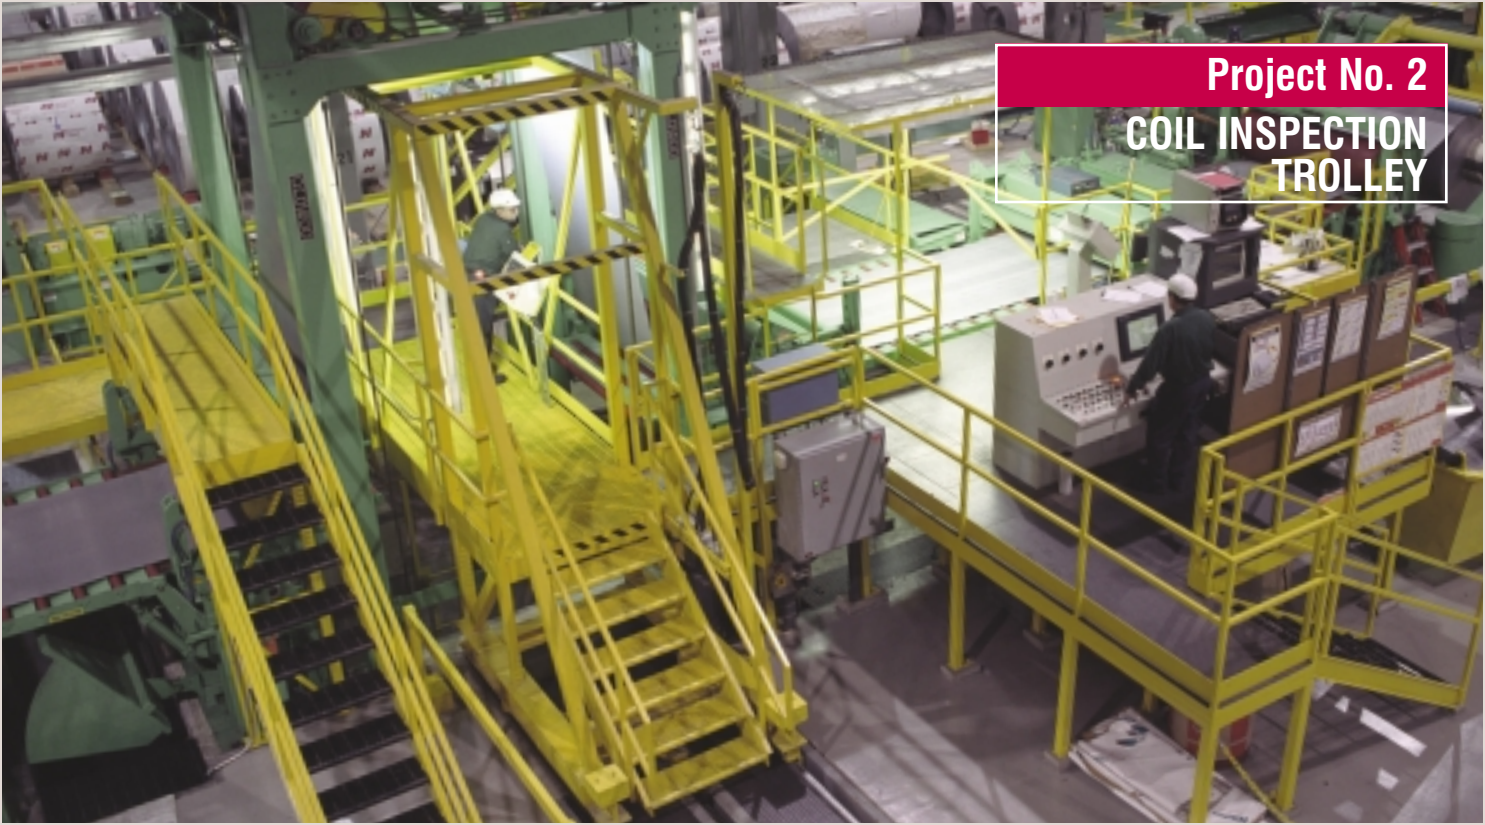
The client required a quality assurance operator to be safely inserted into a vertical inspection tower directly in the path of the moving steel strip, for closer visual observation of the underside of the coil.

A tower guides the steel strip up, over and down in front of the operator at line speeds of 300 to 500 feet per minute; strobe lighting highlights any defects in the surface of the coil. With the inspection trolley in position, the operator has a full view of the underside of the coil as it passes down in front of him. The trolley is guided into position by remote control via a track embedded in the floor and is interlocked with the inspection line operating PLC to ensure complete safety. The inspection trolley is designed to protect the operator from a line or coil failure at any time during inspections. Access and egress from the trolley's spacious platform to ground level is provided from either side. All line controls and inspection lighting panels are installed adjacent to the operator for efficient and ergonomic access.
